TECHNICAL INFORMATION

Charging System On the 1986-1987 Turbo Buick 3.8L

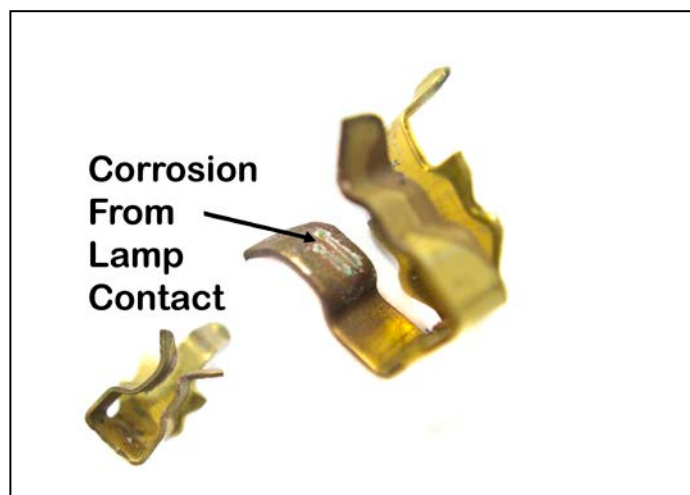
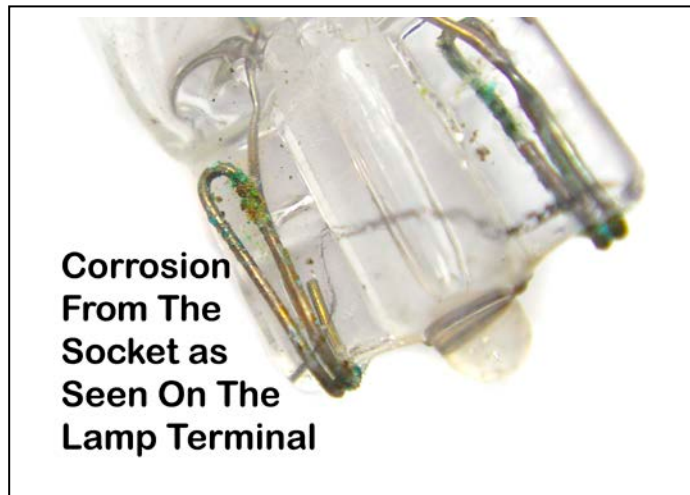
To start with, the VOLTS lamp is a wedge-style bulb, white bead type 194. It's inserted into a twist-lock socket, then installed into the dash cluster. The contacts of the socket are un-plated brass, but the contacts of the bulb are stainless steel, 4xx material that's magnetic. And herein lies the very reason that the system fails.

It's called "galvanic corrosion", which occurs when there are two dissimilar metals in contact with one another, and an electro-chemical process causes one of the metals to corrode. In this instance, the "electrolyte" is simply moisture in the air, which contains salt and other oxidizers. Since the bulb socket contacts are unsealed, moisture gets in, and when electricity flows across the contact area, corrosion is inevitable. As you can see in the image below, the greenish corrosion is copper sulfate, which does not conduct electricity, and as a result, prevents the connection from conducting.

This corrosion caused the VOLTS light to lose its connection to the bulb, and ultimately, to the alternator. **This particular failure caused the owner of the car to spend over \$600 to find it;** flatbed towing, new alternator, new battery cables, three hours of mechanic labor, and finally, sent me the dash to diagnose the problem. The fix was simple, but not understanding why can get very expensive!

In this view, you can see how the corrosion from the brass socket has transferred to the stainless steel wire terminal on the light bulb itself. This corrosion introduces a barrier between the metals, reducing or eliminating the electrical connection between the conductors. With a bit of skill, the corrosion can be cleaned off of the contact area, and the bulb assembly will then function normally again.

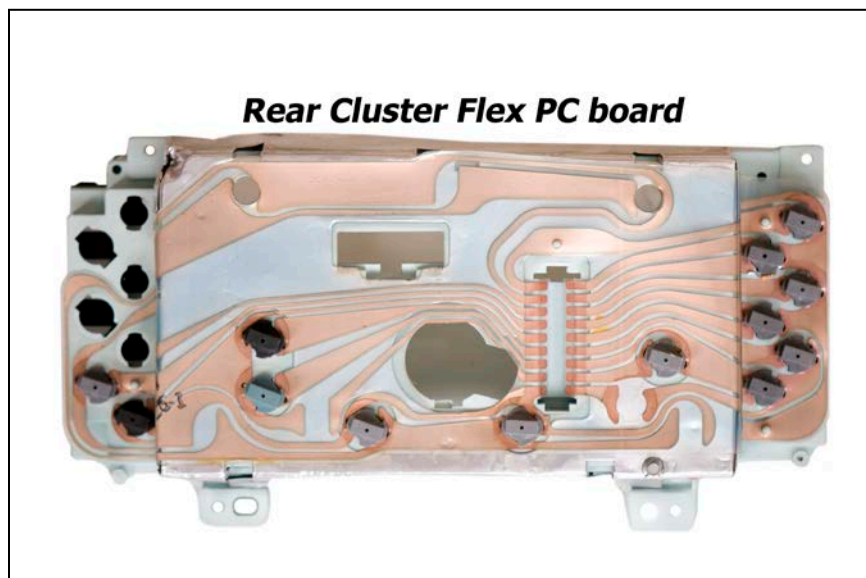
Going back to the dash cluster, the connection is made through a flexible PC board that is positioned behind the dash cluster. In this view, you can see the circuit board:

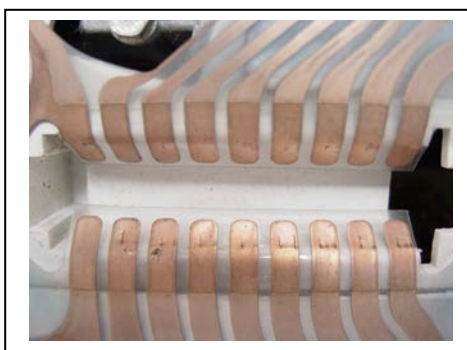
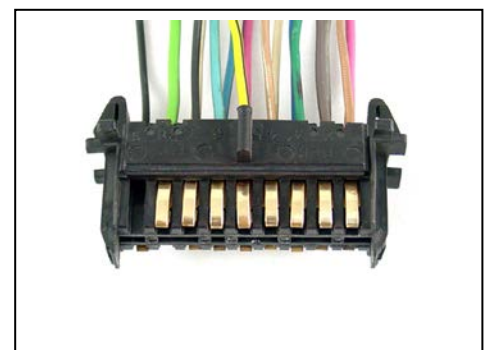
Image on the left shows the flex PC board contacts that engage to the bow connector, as shown on the right. The bow connector is latched into the dash cradle. Be sure that both latches are positioned correctly when the connector is in place.

The flex PC board uses a layered plastic material, with the copper conductors exposed. Since the conductors are bare copper, they are prone to oxidation, which adds resistance to the connections and reduces the electrical conduction. Therefore, routine maintenance includes cleaning and de-oxidizing the copper traces. I'll let you in on a little secret that I used to clean these copper traces. It's called Lysol Toilet Bowl Cleaner. Stay with me here...It's a caustic liquid that should be used sparingly, so here is how you can use it to clean the copper and brass components:

Remove all of the lamp sockets from your dash cluster. Using a Q-Tip and one drop of this cleaner, wipe it on each copper conductor. You will not believe how quickly this stuff works. After the copper is perfectly cleaned, saturate a cloth in water and wash the cleaned copper down so as not to leave any traces of the cleaner on the flex board. Once the traces are clean and dry, use a pencil eraser to polish the copper contacts. Be very careful with the bow contacts in particular; they are damaged easily and can come loose from the plastic base. While I'm on the subject, this liquid will clean anything made of brass or copper more efficiently than the best commercial cleaners on the market. I restored an antique brass cash register using it (throwing this in for effect):

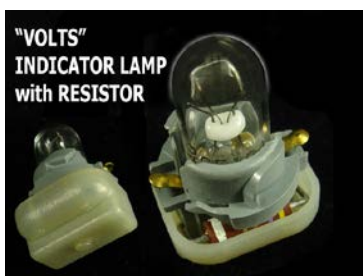
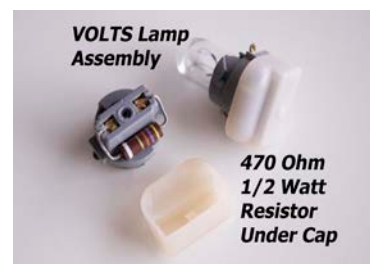
Some of the turbo Regals and Grand Nationals were fitted with a "resistor bulb" assembly. The purpose of this was to enable the alternator to produce current in the event of a burned-out bulb. The specially made socket is easily identified:

Left: Resistor Bulb Socket.
Right: inside view of the specially made socket with a 470 ohm resistor.
