TECHNICAL INFORMATION

CCCI Module "Blown Fuse" Anomaly

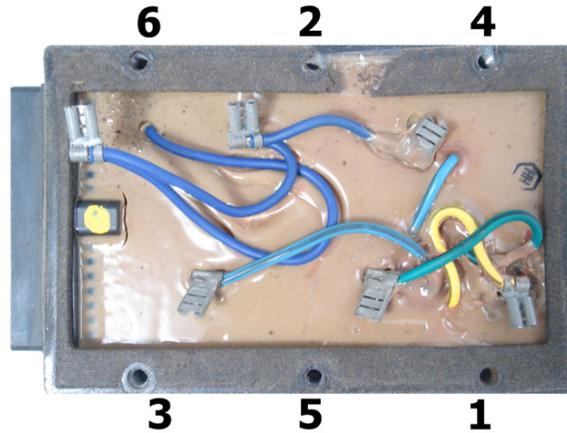
This is the CCCI module with its six terminals exposed. The short was found at the terminal attached to the light blue wire near the No. 3 coil post. This terminal broke thru the sealant and contacted a grounded metal shield.

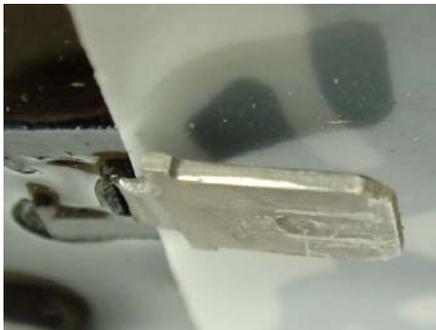
Correct angle

Note the angle of the male spade terminals on the coil pack in the images below. The "correct" angle should be performed when installing the coil pack to the coil module. The "incorrect angle" could place the mating terminal into a potential short-circuit condition on the module, which can cause the "blown fuse" failure:

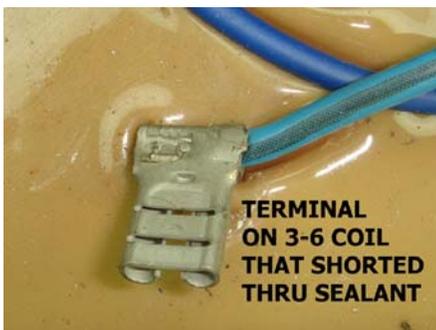
Here is what we discovered. The control terminal on No. 3-6 coil (light blue wire) was installed at an incorrect angle. Because the terminal was pressing into the potting sealant of the module, heat buildup from the coils softened the tan potting sealant, causing the terminal to push through the sealant and contact an internal metal RF shield mounted on the printed circuit board in the module, grounding the terminal to the shield. Note that the shield is buried under the tan potting sealant, about 1/8" under the top surface. Since it was the control side of the coil, the short caused the coil to heat up, creating a 9.7 amp drain on the CCCI fuse – not enough to blow the fuse. When the car started, the load exceeded the rating of the fuse, causing the fuse to open. **Bending the male terminal to the "correct angle" when installing the coil would have prevented this failure.** The correct angle is achieved by first installing the female terminals onto the male spade terminals, then pushing them upward toward the coil pack, away from the potting sealant.

Incorrect terminal angle caused this terminal to protrude deeply into the sealant.

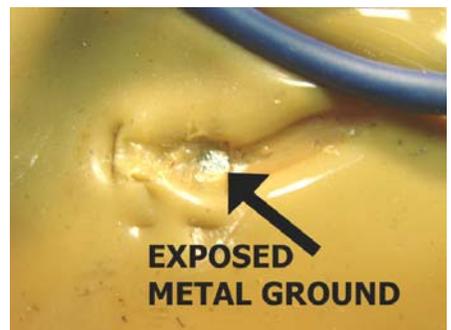
After breaking thru the sealant, the terminal contacted the metal shield causing a short.
