TECHNICAL INFORMATION

Engine Harness Oval Conduit – Broken Conduit Clips – '86-'89 turbo 3.8L

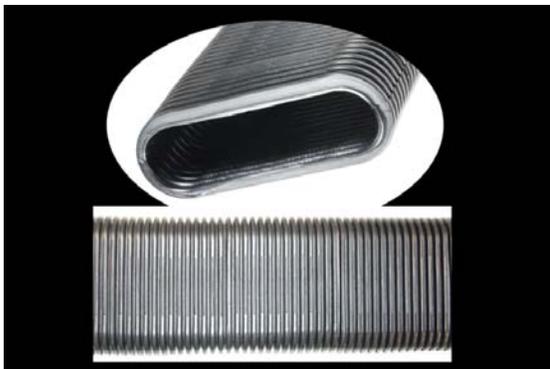
●Oval Conduit

Oval Conduit Clip●

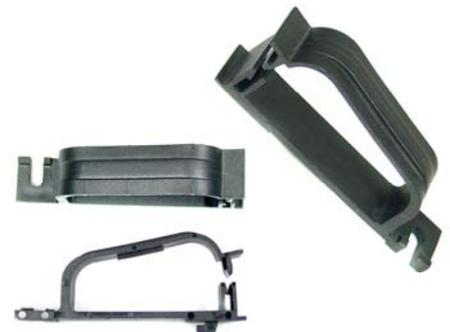
The problem begins when the plastic clips break. This allows the oval conduit to sag and drop down in the engine bay, eventually contacting the down-pipe. Once this happens, the heat from the down-pipe quickly burns thru the harness conduit, contacting the wiring, quickly destroying the harness. Replacing a burned \$800 harness is not a good idea.

Why does the plastic clip fail? Three factors are involved: Original design, material used in the part, and age. The factory design involved a square flange and a single mounting bolt. Early failures were found where the square flange breaks, placing the entire weight of the copper-filled conduit onto the single mounting bolt. Since the upper part of the clip is a "forked" bolt mount instead of a "closed" mount, the excessive weight along with engine heat caused the forked opening to spread, releasing it from the mounting bolt, finally dropping off altogether, causing a sagging appearance in the conduit. The weight of the harness constantly pulls the harness downward and quickly contributes to the failure.

The material used in the original production run (early 1986) had less glass fill in it and was prone to softening with engine heat. Around early 1987, GM discovered the problem and ordered a material change, requiring a greater glass fill and a higher temperature plastic material. Thus, the late production cars had a more reliable part. However, the years and accumulated heat have taken their toll on the clips and today, most if not all of the existing parts in service have failed. The parts supply has dried up and the later version of the part is now long obsolete. Although several years ago, there was an aftermarket steel replacement part available, but that too became obsolete.

Clip Failure

Fast-forward to 2008. You want to restore your 20+ year old turbo Buick and want to replace the damaged clips. Caspers has tooled up for the later version of the clip, using the improved material. Also available is the OEM oval conduit, part number 103011 which is furnished in a length longer than the original, so you can custom-fit it to your engine bay. This will enable you to restore that section of the engine harness to OEM specifications and bring the original look and fit back to your wiring harness.

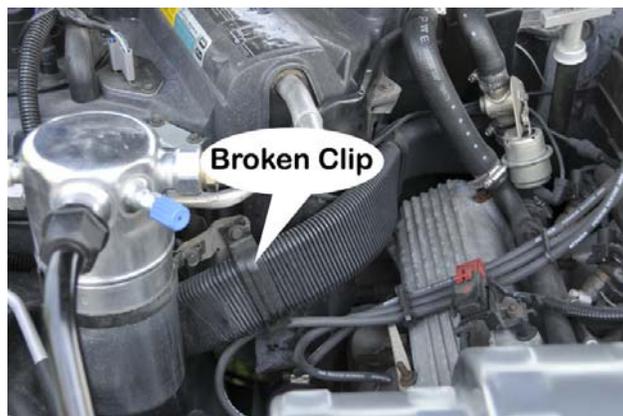
This is the latch that usually fails
