Bulkhead connector removed from ECM

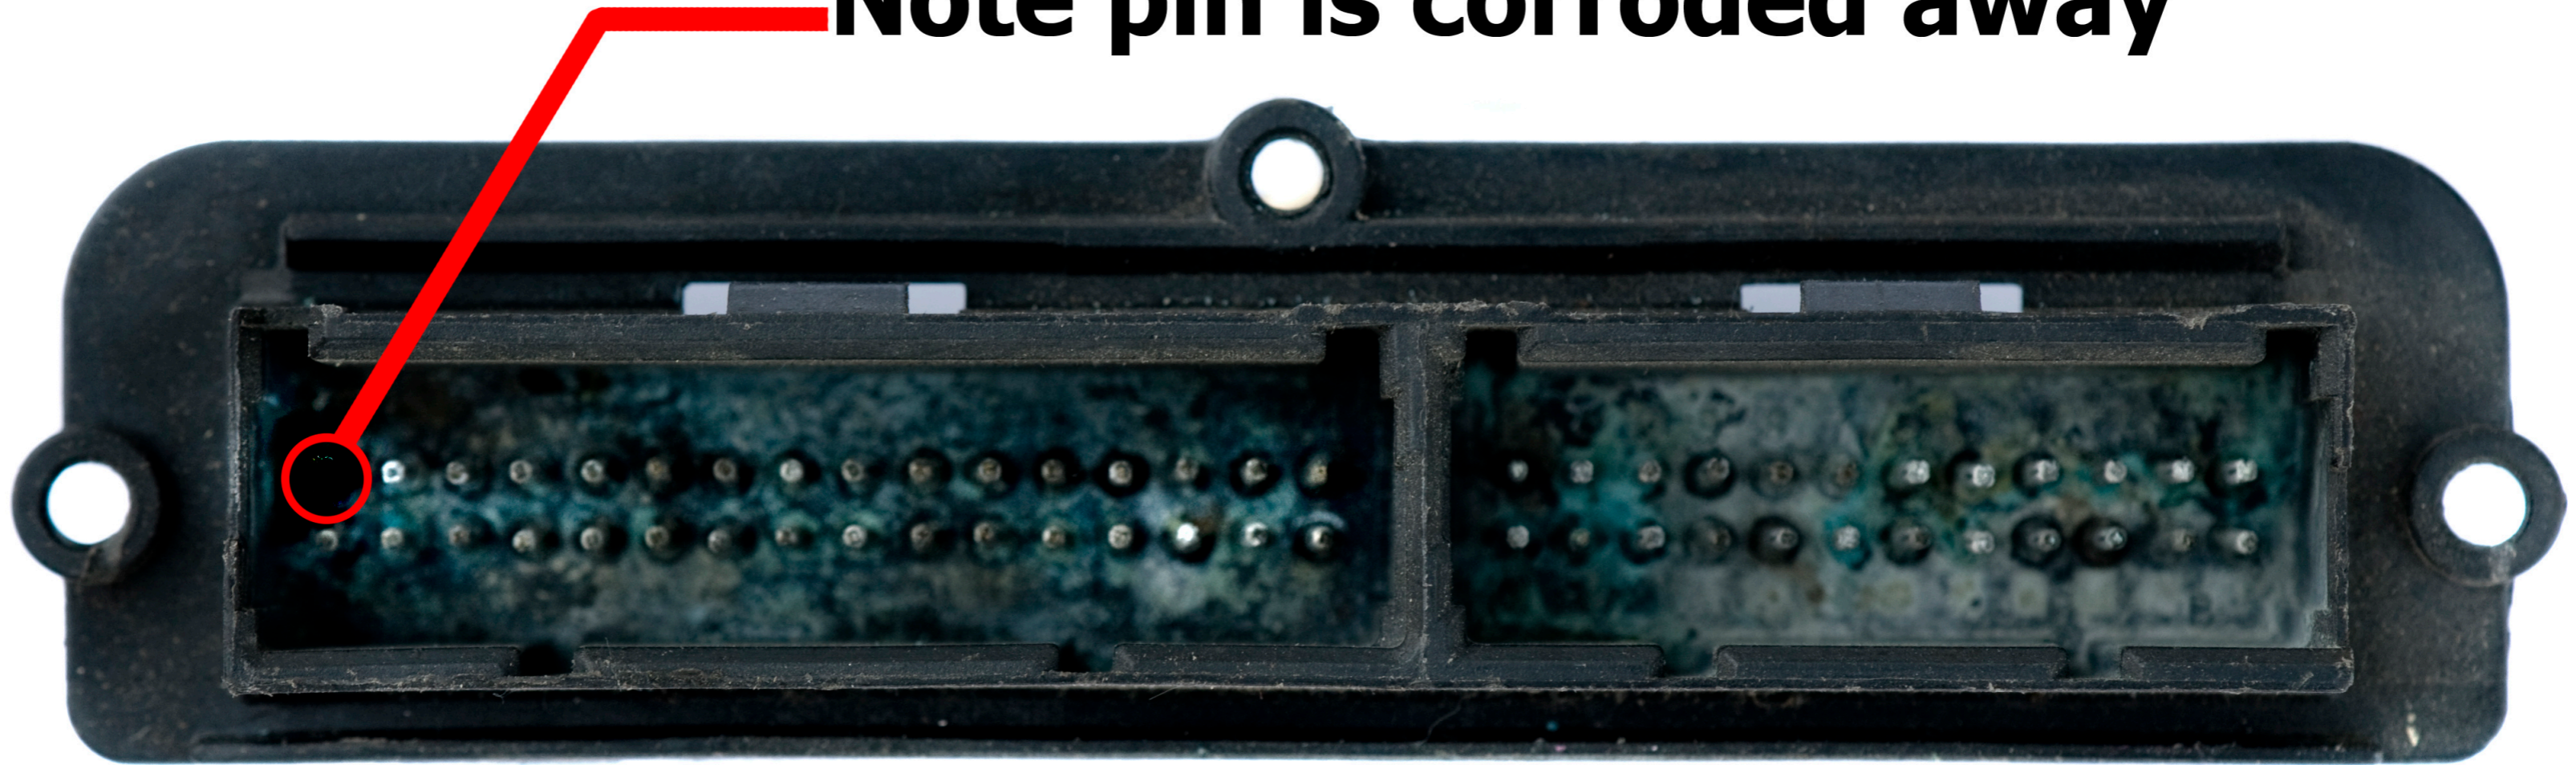
Pin C16 (MEM FEED)

Note pin is corroded away

Green and white corrosion due to presence of water in the connector.
